## CHRISTENSON OIL CSM Site Summary

Oregon DEQ ECSI #: 2426

3821 NW St. Helens Road

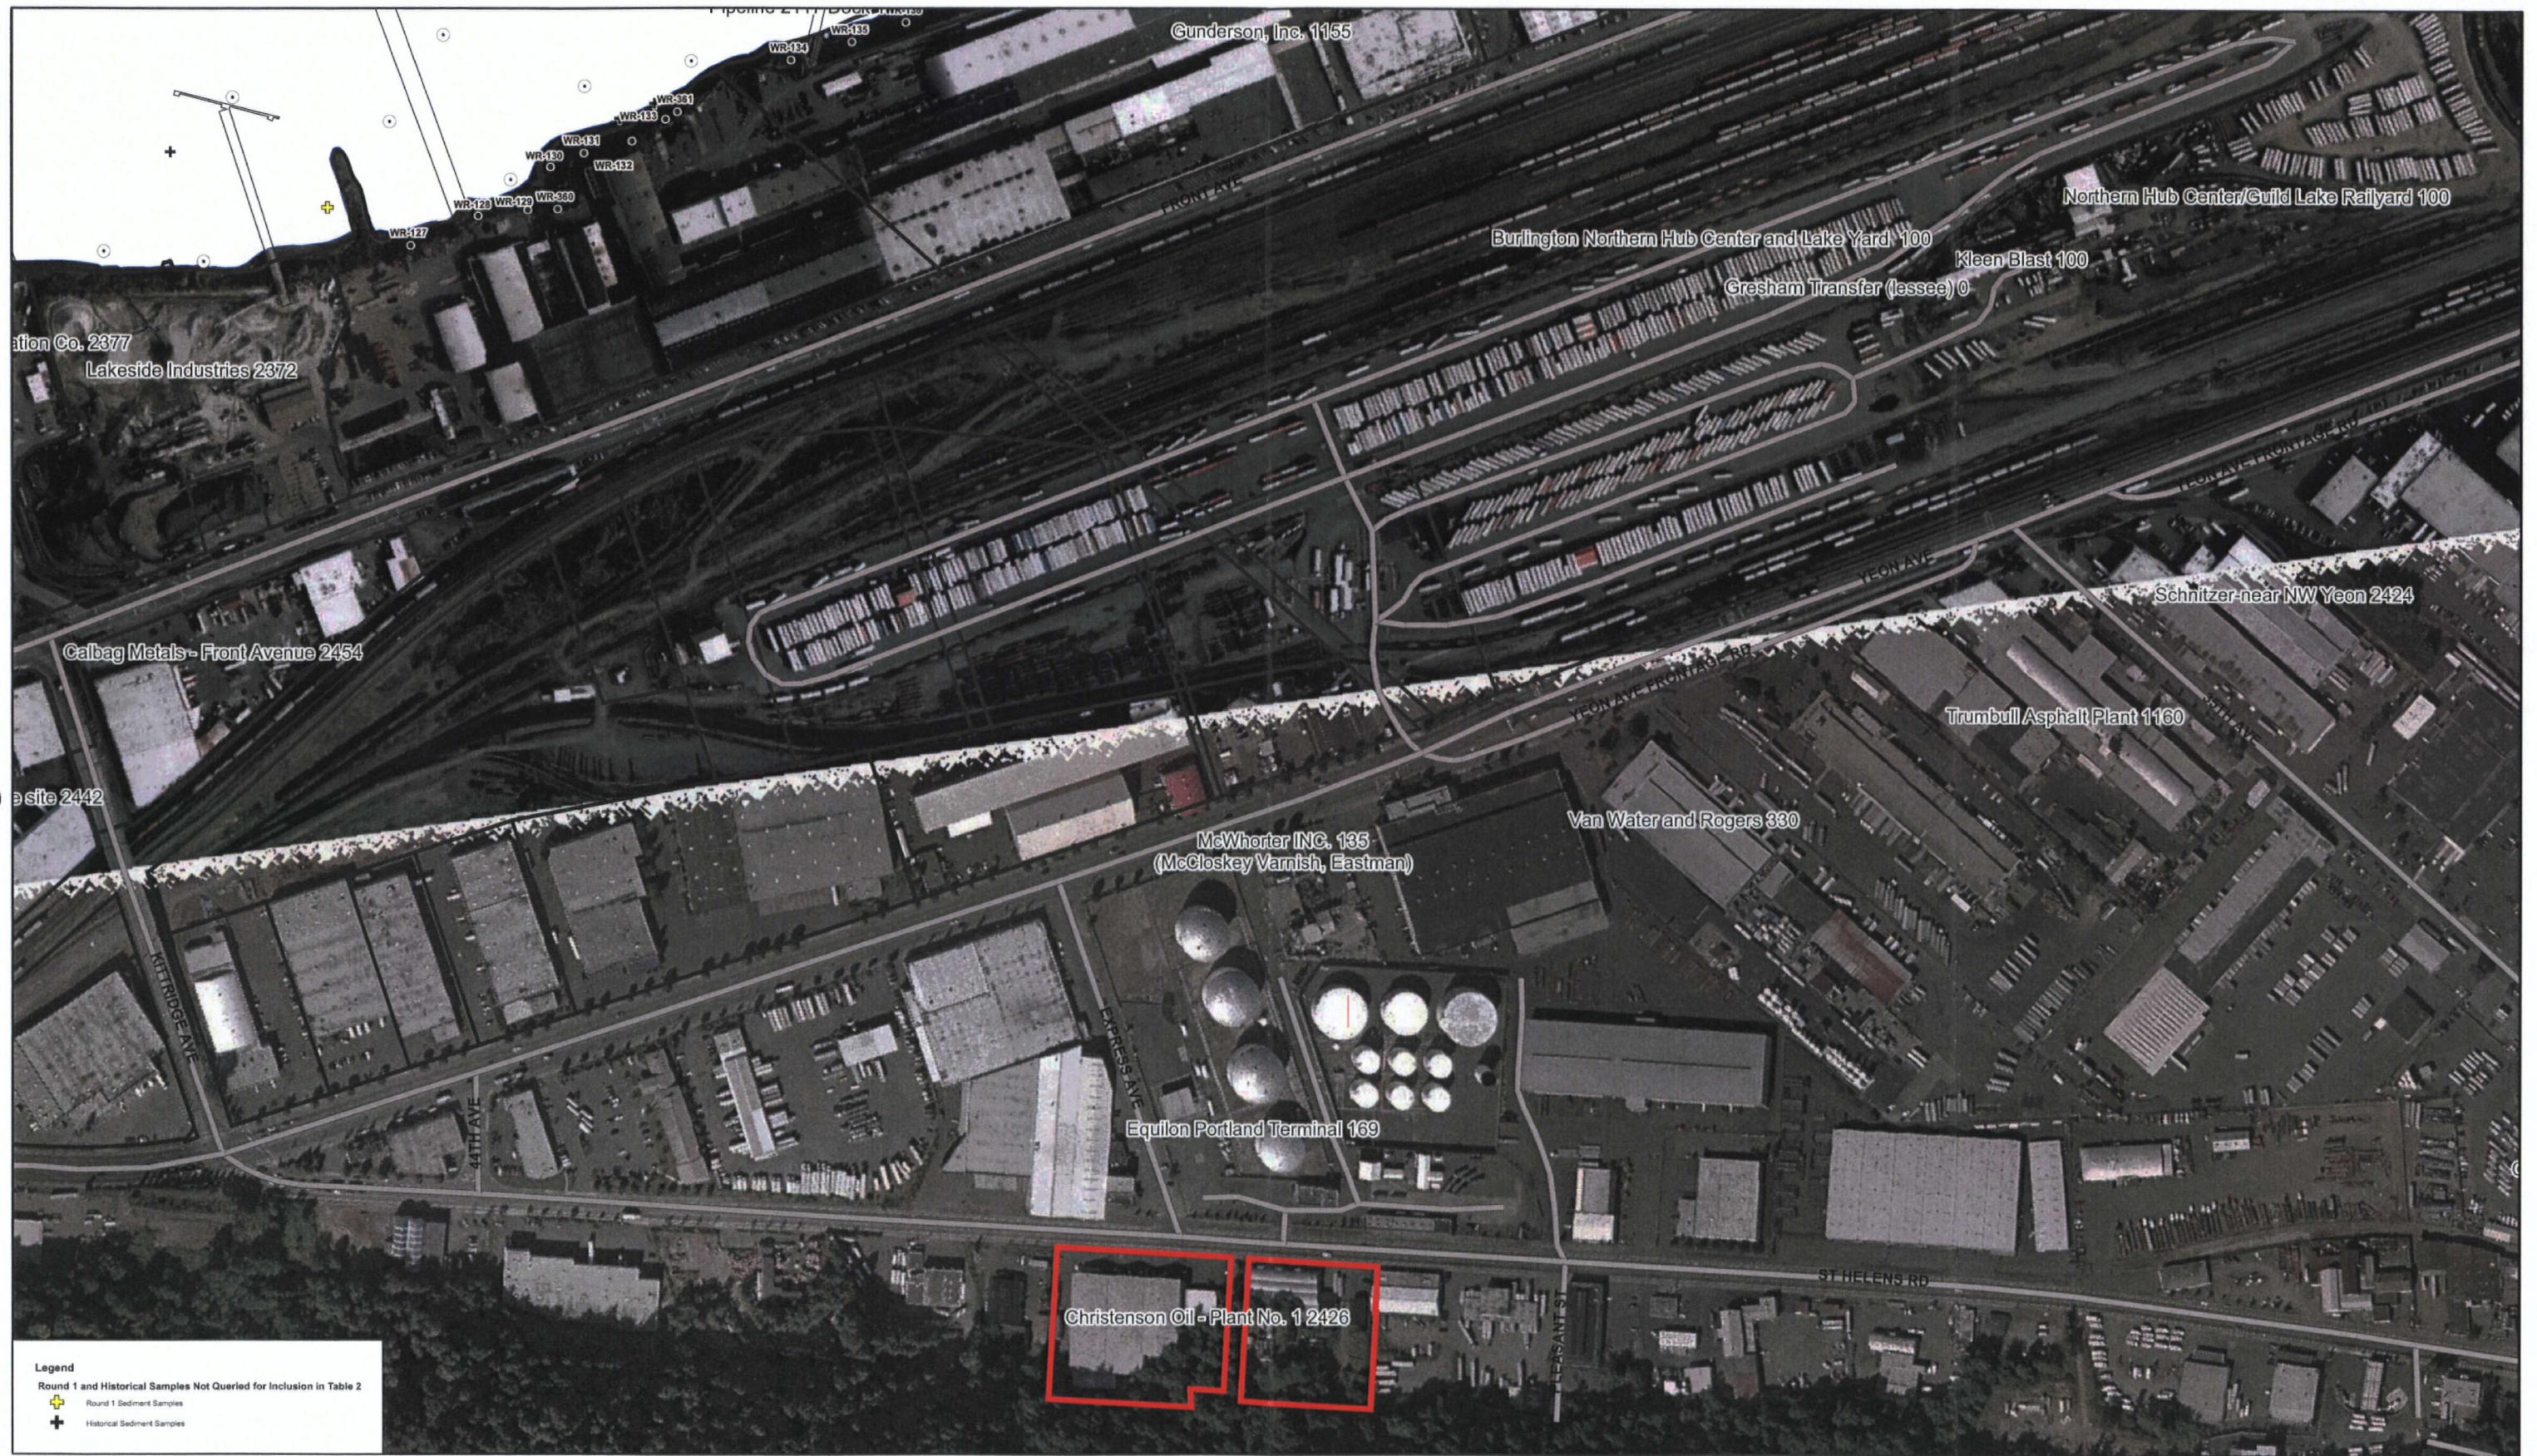
Figure 1. Site Features

Figure 1-Site Features  
 Portland Harbor RI/FS  
 Conceptual Site Model  
 Christenson Oil  
 ECSI 2426
